To: Cambridgeshire County Council General Purposes Committee
Authors: Richard Cushing and Edward Leigh, Smarter Cambridge Transport
Subject: Review of Capita report and recommendations on guided busway defects
Contact: 01223 312 377 / edward@smartertransport.uk / [@SmarterCam](https://www.facebook.com/SmarterCam)

Cambridgeshire Guided Busway Defects

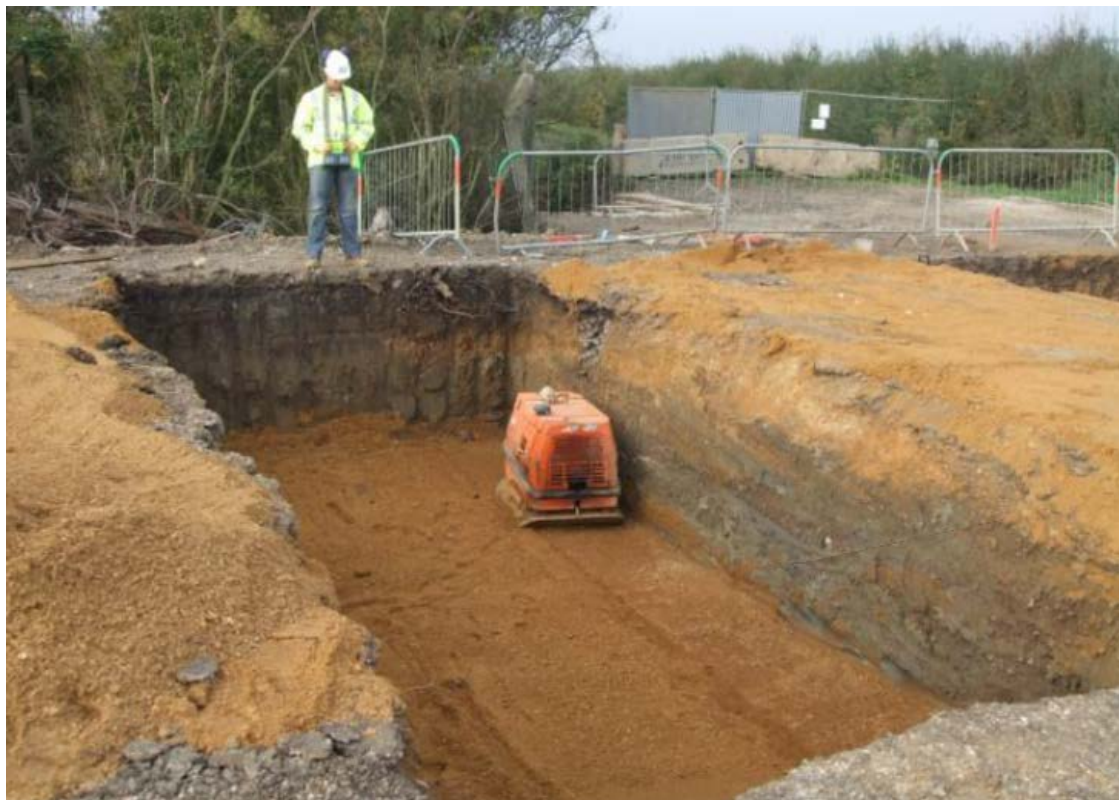
Figure 2: Shallow foundation [2-Fig 7]. 821 of these are to be re-excavated, deepened and re-instated

The size of the 'shallow' foundations are noted in the 2014 report [1 – p7, Fig 7], reproduced above (Fig 2). It would appear from the photograph that the volume of material present in such a foundation would require several journeys by heavy vehicles to remove it. The report notes that 821 of these foundations are to be excavated, deepened and re-established, using compacted Class 6N fill. It is unclear whether all of the excavated material will be removed from site and fresh material brought to the site, or whether some of the original material may be re-usable.

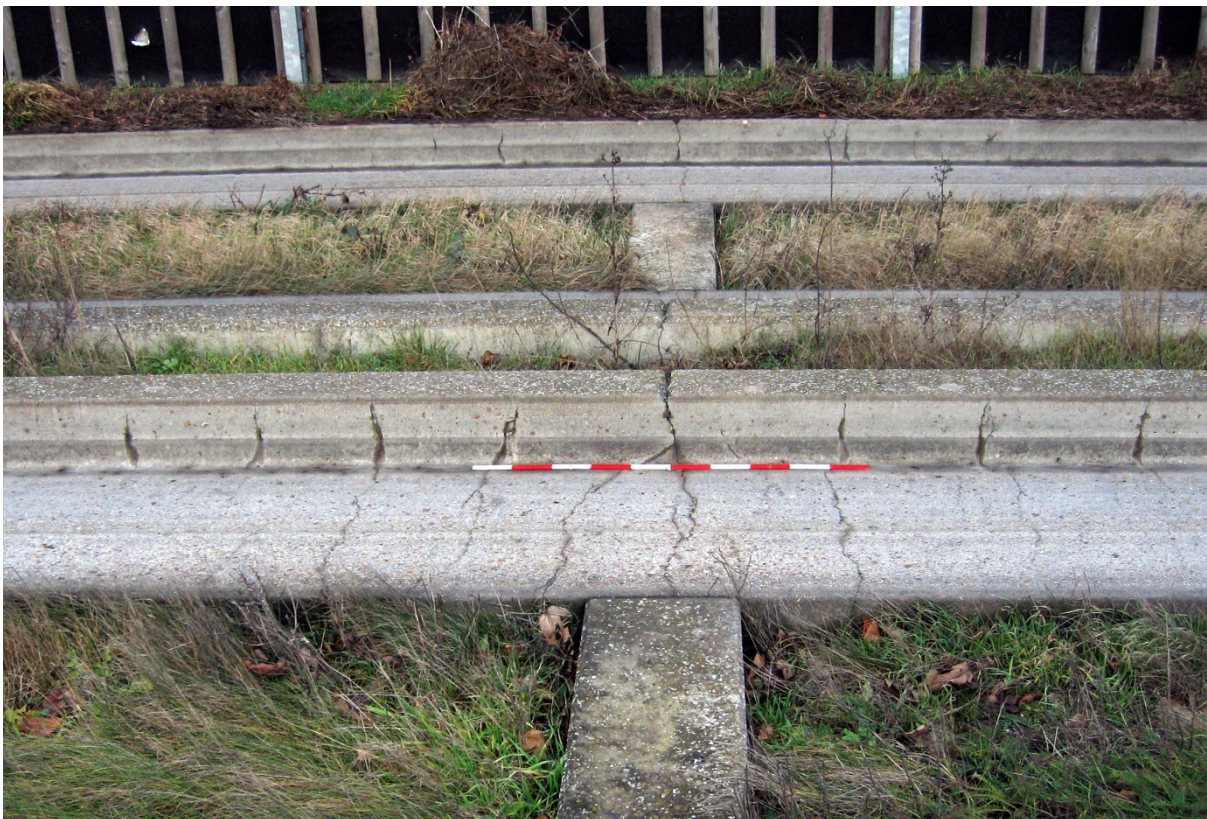
We have walked the whole length of the Guided Busway from St Ives to Milton Road. Many of those beams contain cracks around the central support. Typically there is a crack emanating from the central V-notch. In some places, cracks extend into the running surface (Fig 4).

Figure 4: Centre of guide rail, showing V-notch and cracking. Scale bar: 1m.

Figure 4 shows part of the St Ives-bound guideway in the foreground, with the Cambridge-bound guideway behind. The length of beam in the foreground is approximately three metres. This pattern of cracking is typical of many in the Histon area.

Is it the case that the cracking shown in the beams in Figure 4 is caused by heave in the centre of the beam or is there some other explanation?

Without treatment these cracks will worsen due to freeze-thaw and other factors. The report suggests injection with resin, and treatment with bitumen paint [2 – p41, para 142-3]. Given the extent of cracking shown above which has appeared within five years, it does not seem likely that this treatment will extend the life of the beams for a further thirty-five years. It is also noted that the amount of cracking is variable, but the degree of cracking at any location along the route is generally mimicked in all four beams.

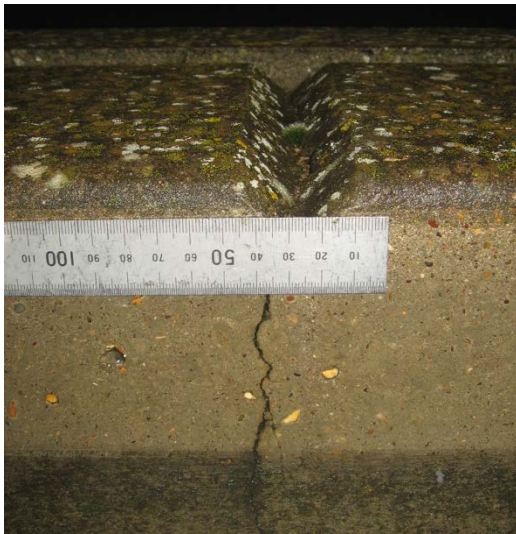
‘... the cracking over the central support is likely to increase (we have calculated this to be around 0.3mm) ... ’ [2 – p53, para 166]

The timescale of the increase of 0.3mm quoted in the report is unclear, but presumably refers to the remaining life of the beam – approximately 35 years.

Figure 5 shows a crack in one beam. At the top of the upstand, adjacent to the V-notch, the crack was measured and found to be 0.6mm wide. This gap in this beam has occurred over five years.

Figure 5: Crack originating at V-notch. Measured photogrammetrically as 0.6mm.

The report suggests treatment with resin and bitumen paint [2 – p41, para 142-3].

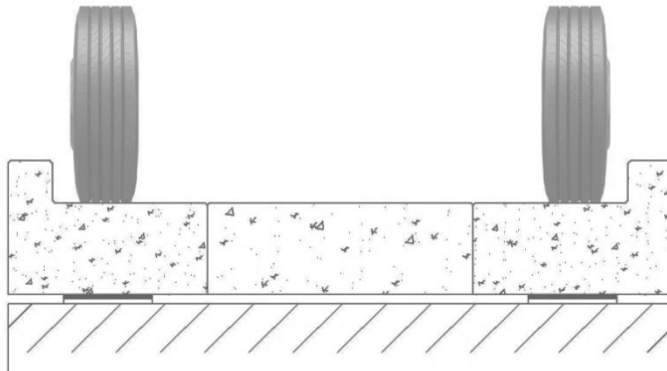
Figure 6 indicates the loading from front (single) (Fig 6a) and rear (double) wheels (Fig 6b). It will be seen that the bearings directly support the load on the front wheels.

Figure 6a: Front wheels load the beams above the bearing points.

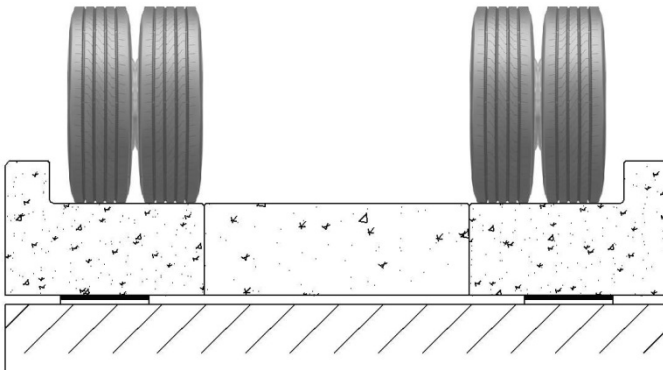
However the rear wheels put a load inside the bearing and shim stack. The inner edges of the beams roll away from the spacers; the through bolts stretch and allow the beams to push the beams outward. Friction between the foundation block, bearing, shims and beam is not sufficient to constrain the movement.

Figure 6b: Rear wheels create an offset load on the bearing stack, causing the beams to roll. This puts stress on the beams, spacers and fixings, and tends to force the stack outwards as shown below.

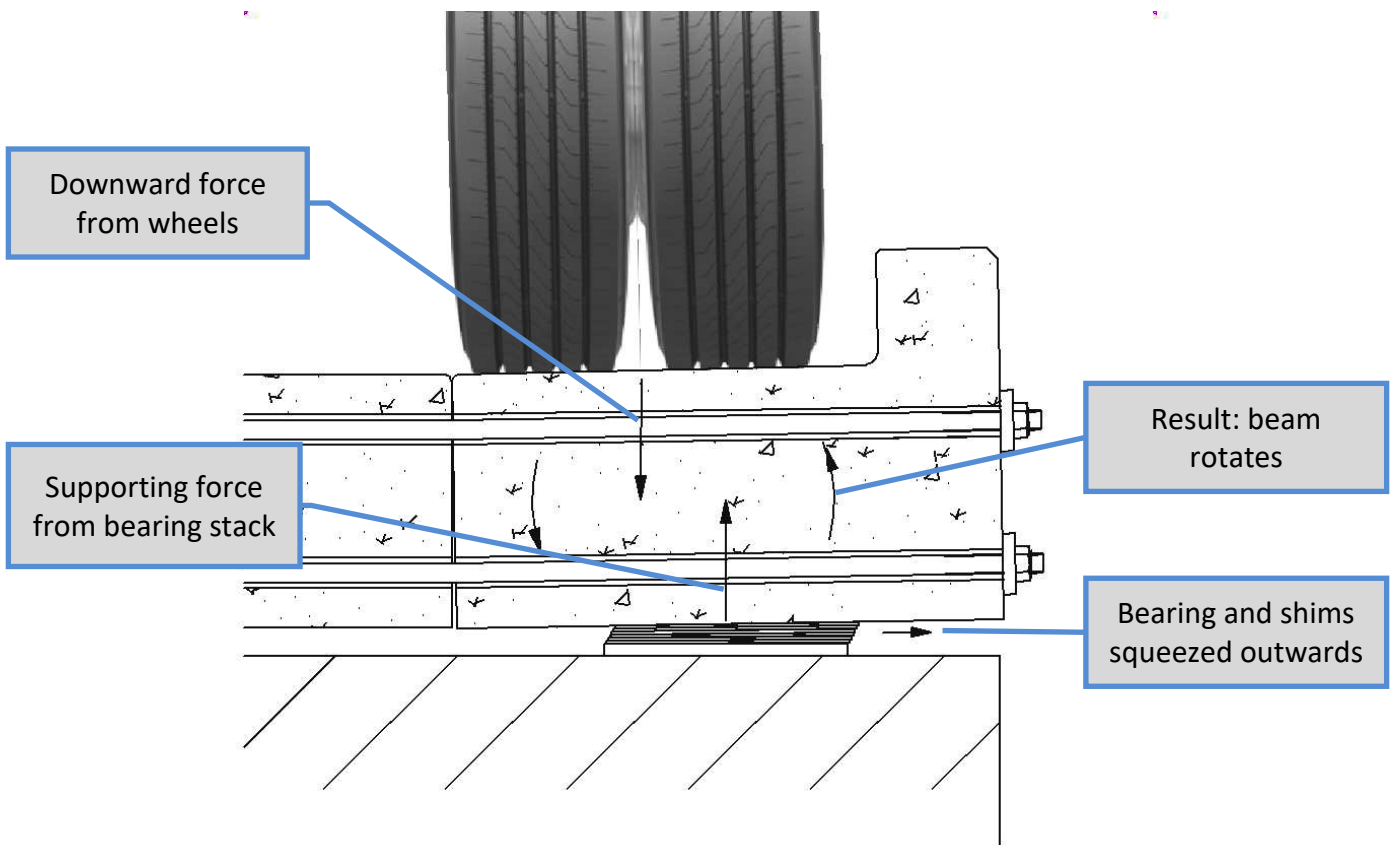
Figure 6c: Detail, showing turning moment created by loaded wheels. The bottom of the beam rolls outward. The beam is partly constrained by the retaining bolts, but the bolts stretch and allow the stack to slide.

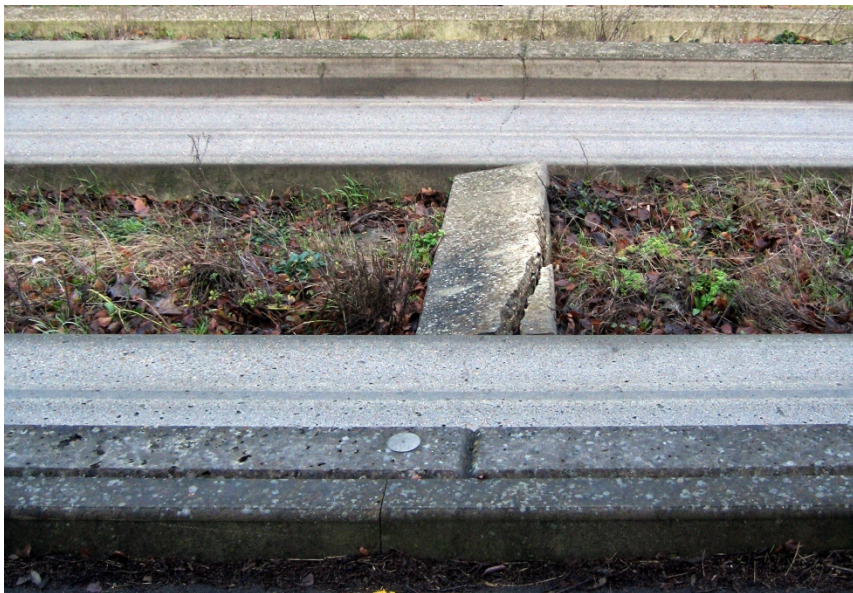
Fig 7 Fractured centre spacer. The spacer has pitched forward. The top of the beams have apparently rolled inward and pinched the spacer, as indicated in Fig 2c, above, resulting in fractures at both ends.

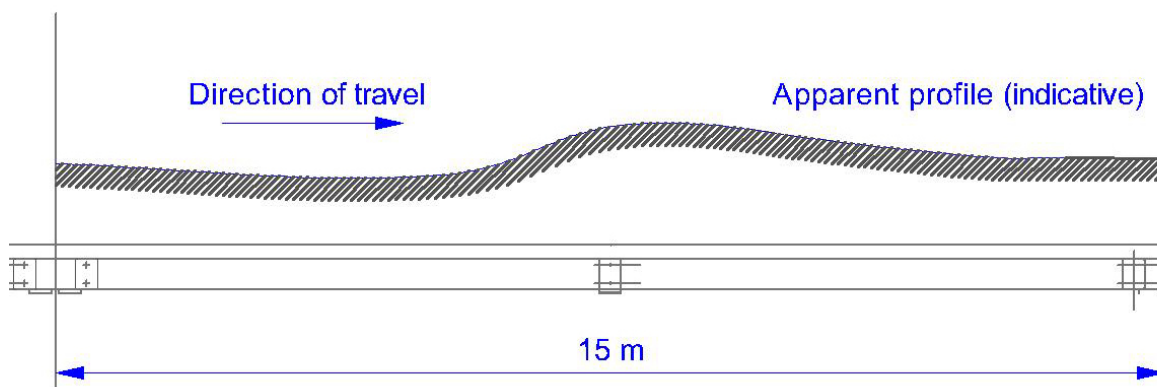
Figure 8: Indicative profile of the ride for extended sections of the Busway. The observed motion of the vehicle will differ from

the profile of the beam, having been modified by the vehicle suspension.

We note comments regarding heave, particularly in relation to shrinkable clay and trees [2 – p58 para 187]. However, the ‘hopping’ occurs over extended lengths of the Busway. The geology is varied, but the phenomenon is apparent over significant stretches of the route, and we suggest that a mechanism other than shrinkage and heave may be present.

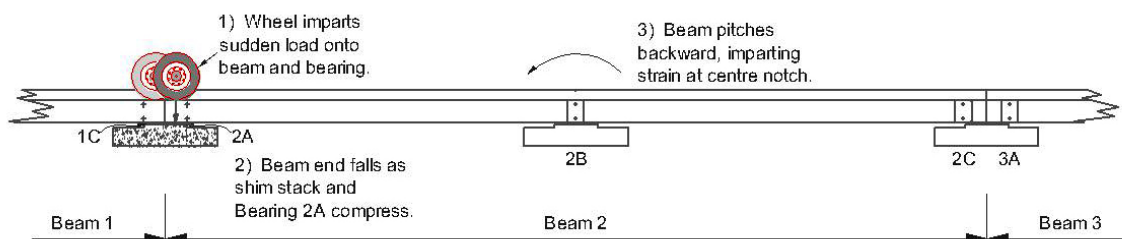
Figure 9: Action and reaction of a beam as it is receives an impact from a loaded wheel.

With an 18 tonne dual axle bus approximately 3.5t is taken on each of the front wheels. With the wheel at the end of Beam 1, the load on 1C is a total of 7.3t (beam with bus), and the load on 2A is 3.8t (beam alone).

We suggest that a significant reason for cracking is cyclical percussive loading as bus wheels hit the start of each beam.

Bearing 2A will take an impact load from the wheel. This will be imparted to the foundation through the shims and bearing. A small movement in the foundation slab will be imparted to the underlying soil. By the time the rear axle arrives at this point the load from the front will be almost over the centre bearing, and Bearing 2A will have been substantially offloaded. The second axle of the bus imparts a percussive load of approximately 11t with even greater effect than the first.

We suggest that a significant reason for differential settlement of the foundations is because of percussive loading by wheels as they impact the start of the beam. The loading on the centre foundation is much smoother by comparison.
