To: Cambridgeshire County Council General Purposes Committee
Authors: Richard Cushing and Edward Leigh, Smarter Cambridge Transport
Subject: Review of Capita report and recommendations on guided busway defects
Contact: 01223 312 377 / edward@smartertransport.uk / [@SmarterCam](https://www.facebook.com/SmarterCam)

Cambridgeshire Guided Busway Defects

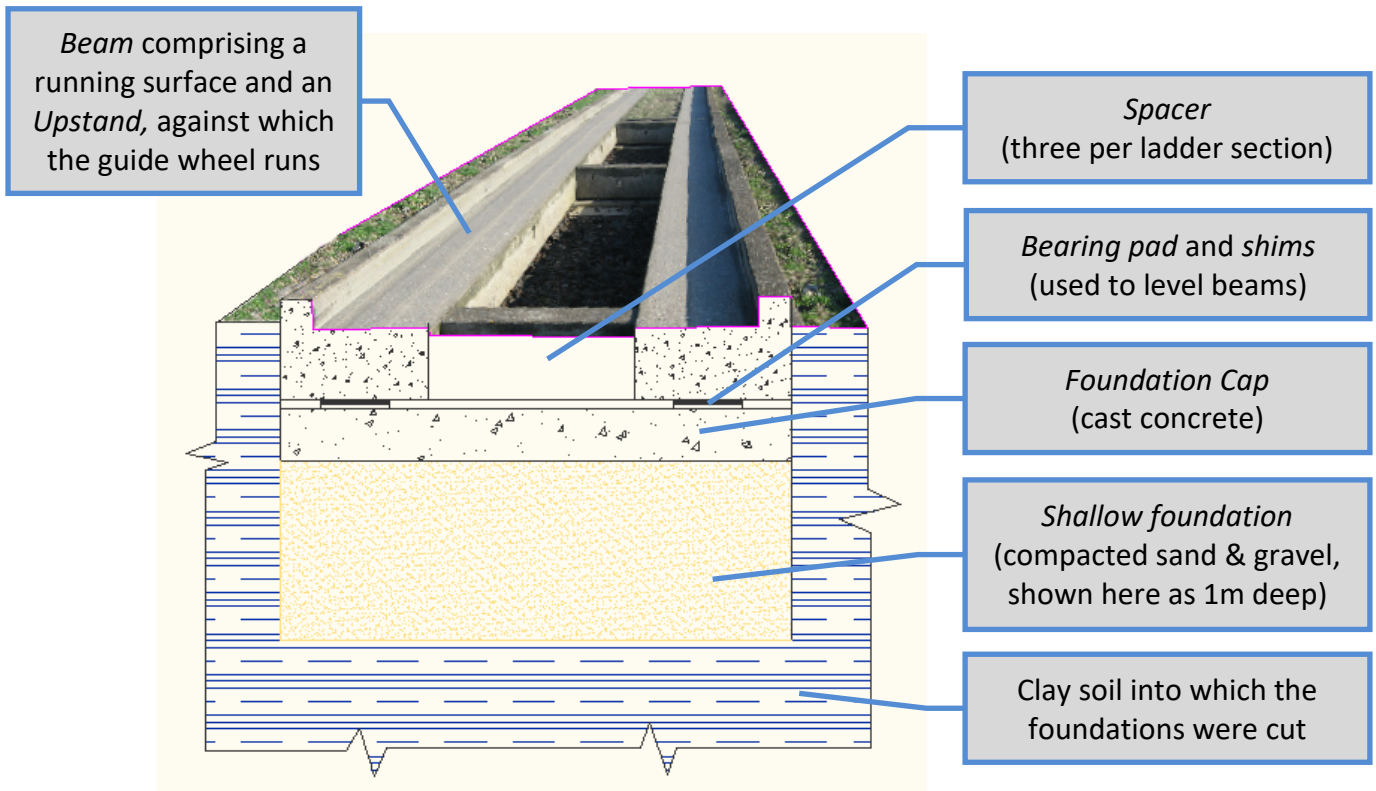
What analysis has been carried out to quantify the risk of derailment (e.g. owing to a beam up-stand breaking away under load, or a guide wheel riding up a damaged beam end)? Has the effect of derailment been modelled for a double-decker bus, in particular on a section where the centre of the guideway is open or in-filled with loose rubber, as shown in Fig 1 below?

Figure 1: Cross-section of the busway showing a typical 15m 'ladder section' and one of three shallow foundations.

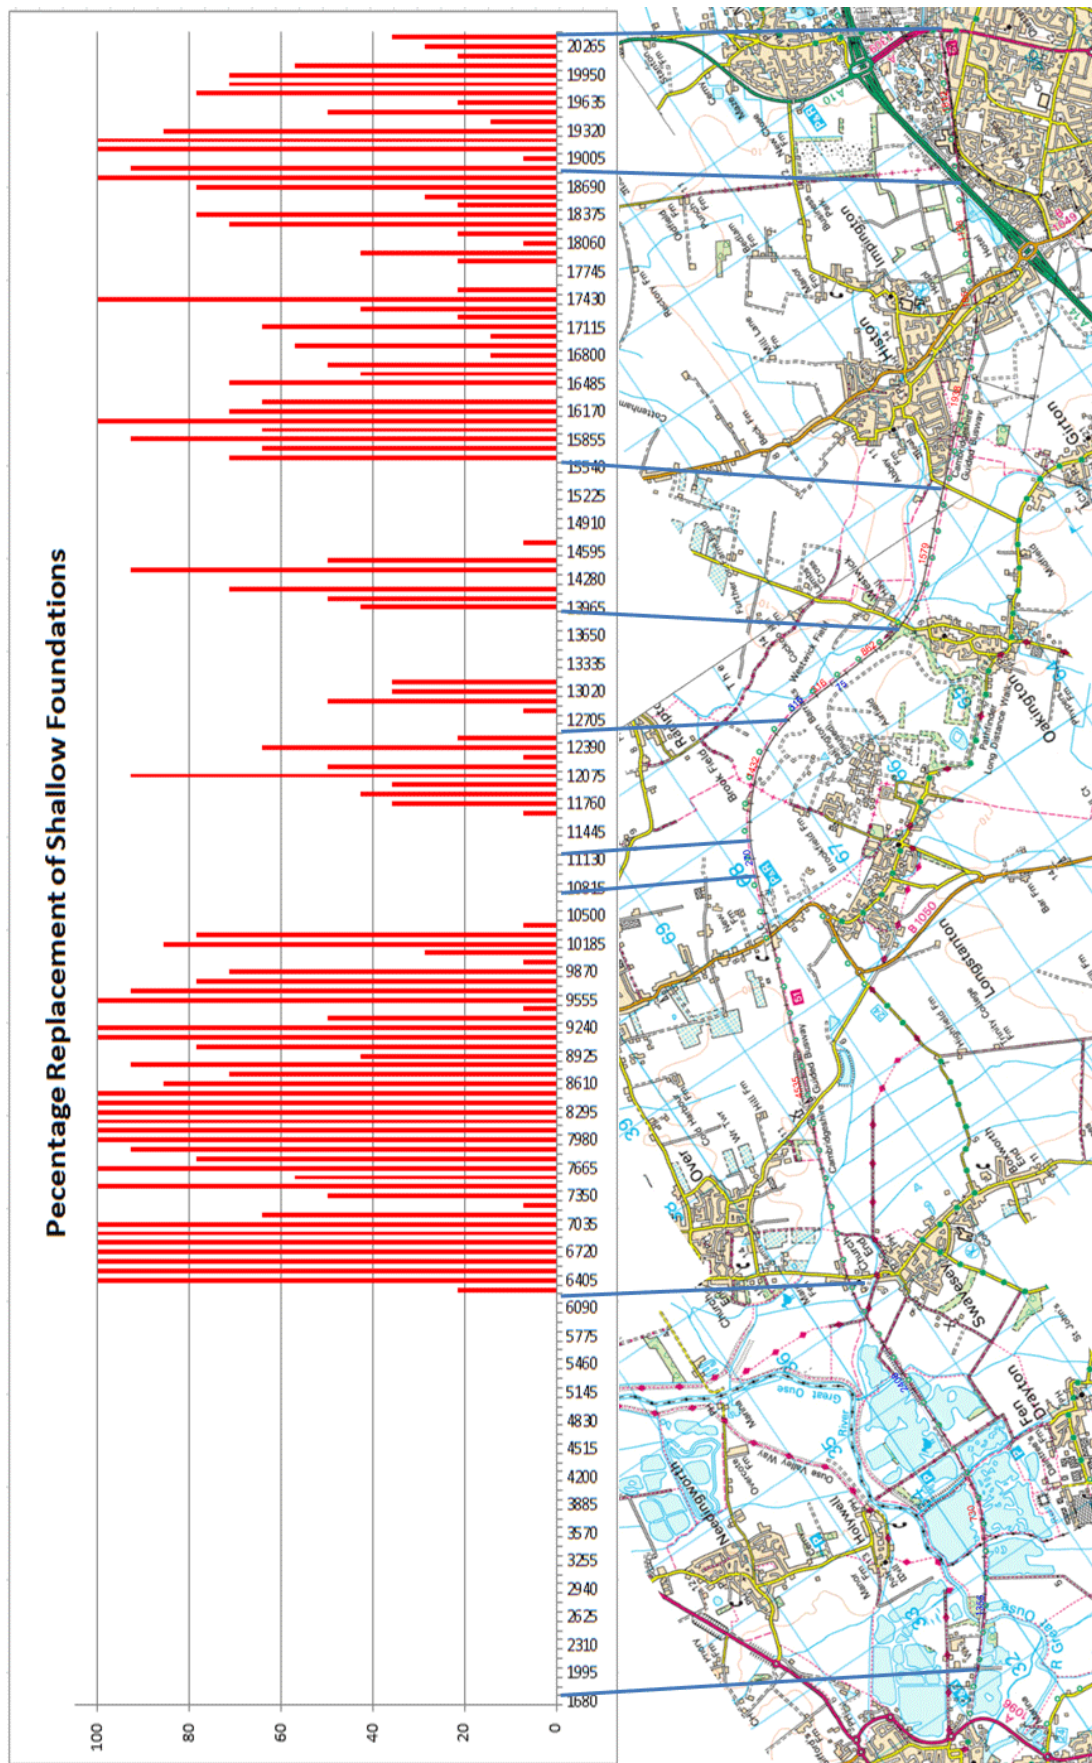
Buses on the Guided Busway run on concrete beams, 10m or 15m long. These are supported on foundations that are either piled or ‘shallow’ compacted material. Reports by consultants [1 & 2] have identified that 821 out of 1791 of the shallow foundations on the northern section (St Ives to Milton Road) are failing and require rebuilding.

Figure 3: Location of foundations to be replaced. Piled foundations shown in blue, shallow foundations in red.
